**NASA CR-72850**

# **EVALUATION OF HIGH TEMPERATURE ELECTRICAL MATERIALS AND COMPONENTS**

**A. J. Krause, W. S. Neff and J. W. Toth**

**Westinghouse Electric Corporation  
Aerospace Electrical Division  
Lima, Ohio**

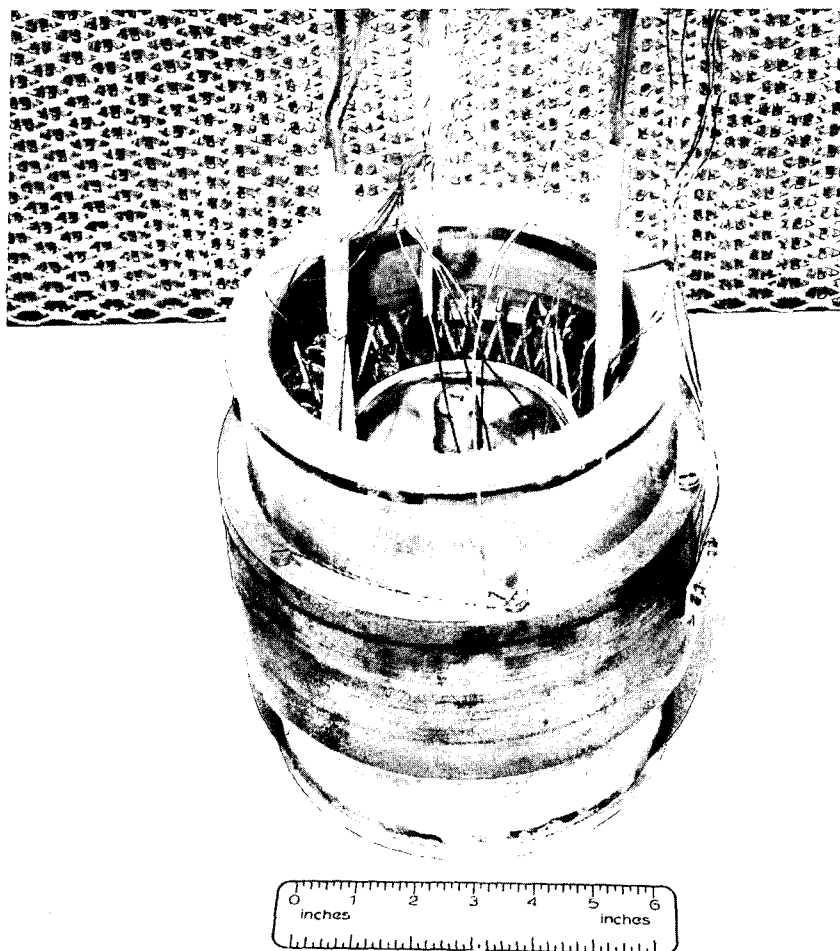
Figure 15. - Photograph of the Stator and Bore Seal Capsule After the 10,000-Hour, 1300° F Ultrahigh Vacuum Endurance Test. Refer to figure 1 and table 1 for location and identification of stator materials.

Visual Examination of the Stator After Removal from the Test Chamber - A visual examination of the stator, performed immediately after removal from the test chamber, revealed some gray discoloration of the insulation materials and a general dulling of the exposed metallic surfaces attributed to deposition of evaporated materials during thermal-vacuum aging. The exposed surfaces of the conductor insulation were gray. Many of the conductor insulation "S" glass fibers on the conductor end turns had been fractured during winding, thereby causing some fraying; but this condition had not progressed further during the aging (see figure 17). The glass fibers were mechanically weak with low interfiber bonding. The adhesion of the wire insulation to the Inconel cladding was also weaker than after firing. The Inconel surface under the insulation was bright and not discolored.

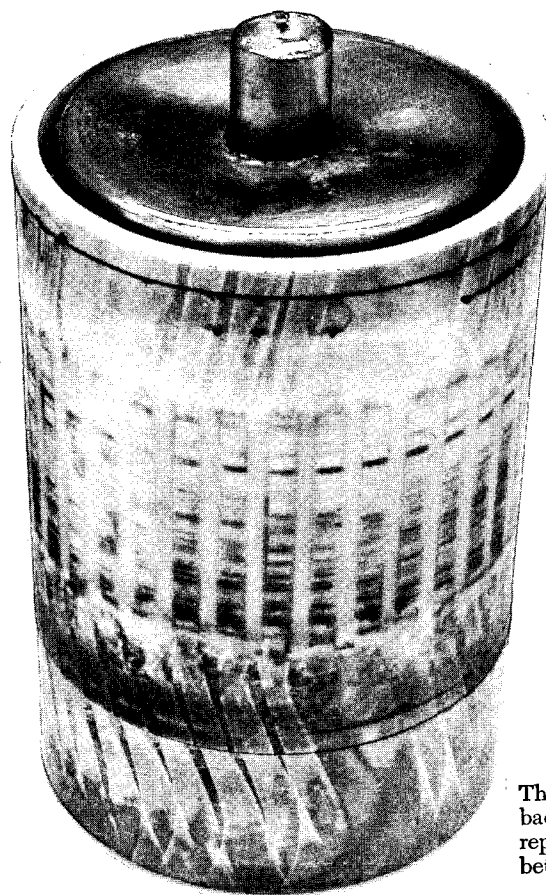
Figure 16. - Photograph of the Bore Seal Capsule and Support Pedestal After the 10,000-Hour Potassium Exposure Test at 1300° F in Vacuum.

Exterior Deposits. - After removal from the stator, the bore seal was visually examined. A deposit with the same pattern as the iron-27% cobalt alloy stator laminations was noted on the beryllia bore seal tube as well as a general darkening of the beryllia surface to a light gray color. Figure 16 shows the bore seal after removal from the stator. A band of dark gray deposits was also seen on each end of the beryllia tube.

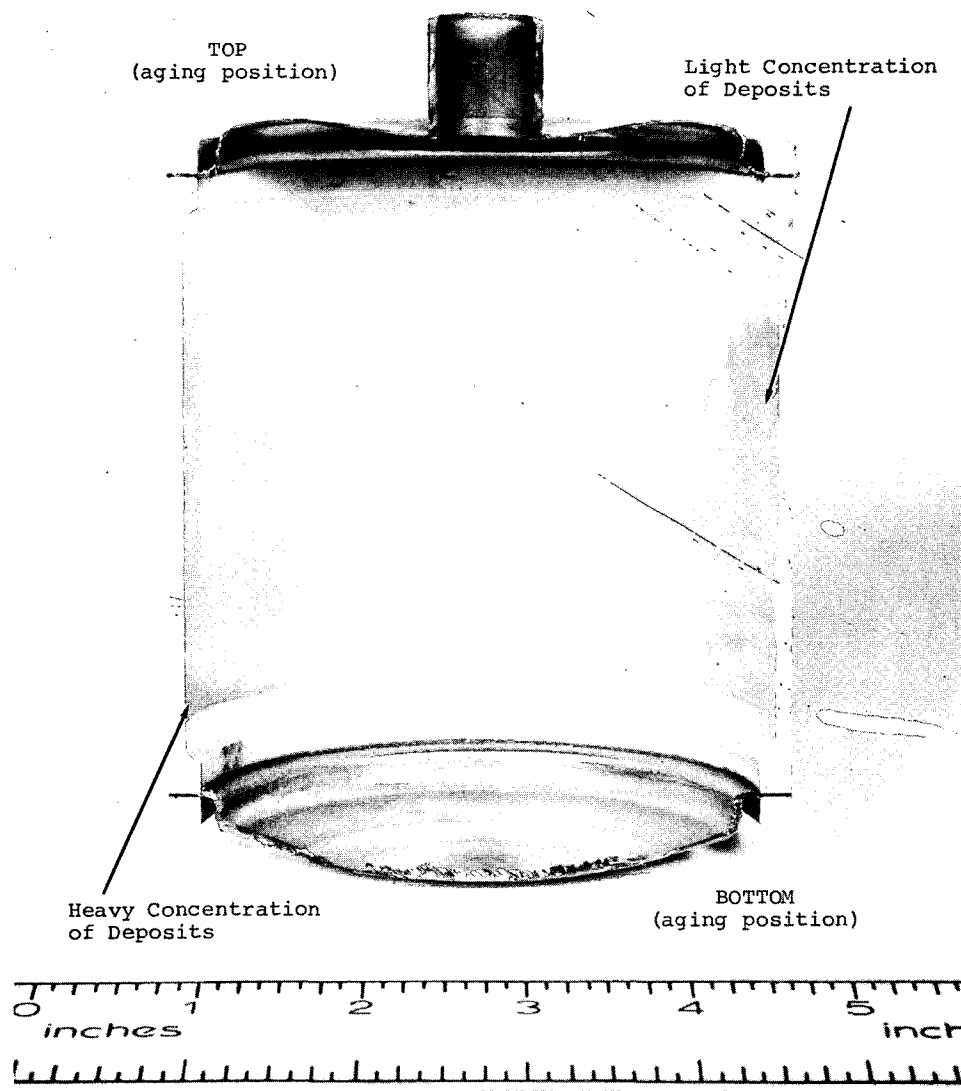
Interior Deposits. - After the bore seal capsule was sectioned, deposits were observed on the ceramic interior. The interior of one half of the bore seal capsule is shown in figure 20. A definite line of deposits may be seen around the interior circumference at approximately the same level as the top of the previously discussed condensed potassium fillet. A general cover of light deposits may be seen on other beryllia areas with pattern of heavier deposits in some areas. These deposits all exhibited a metallic appearance. Qualitative spectrographic analyses were performed on both these deposits and the clean beryllia substrate. Platinum was the major element in the deposit. No platinum was found in the clean substrate beryllia. Rhodium was specifically looked for but was not found in the deposit on the bore seal interior. The solubility limit of platinum in potassium may have been reached during cooling and condensation when the bore seal capsule was cooled from the 1300° F exposure temperature, thus causing excess platinum to deposit on the capsule wall. (The heaviest deposit appeared at the top of the condensed potassium fillet.) Rhodium, the predominant impurity element in bore seal capsule potassium (see table 5) apparently was not present to the limit of solubility. The suggested source for platinum and rhodium is from a section of platinum - platinum-10% rhodium thermocouple, possibly remaining in the capsule after brazing or clean firing.

Figure 20. - Beryllia Bore Seal Capsule Interior After  
10,000-Hour, 1300° F Potassium Vapor  
Exposure.

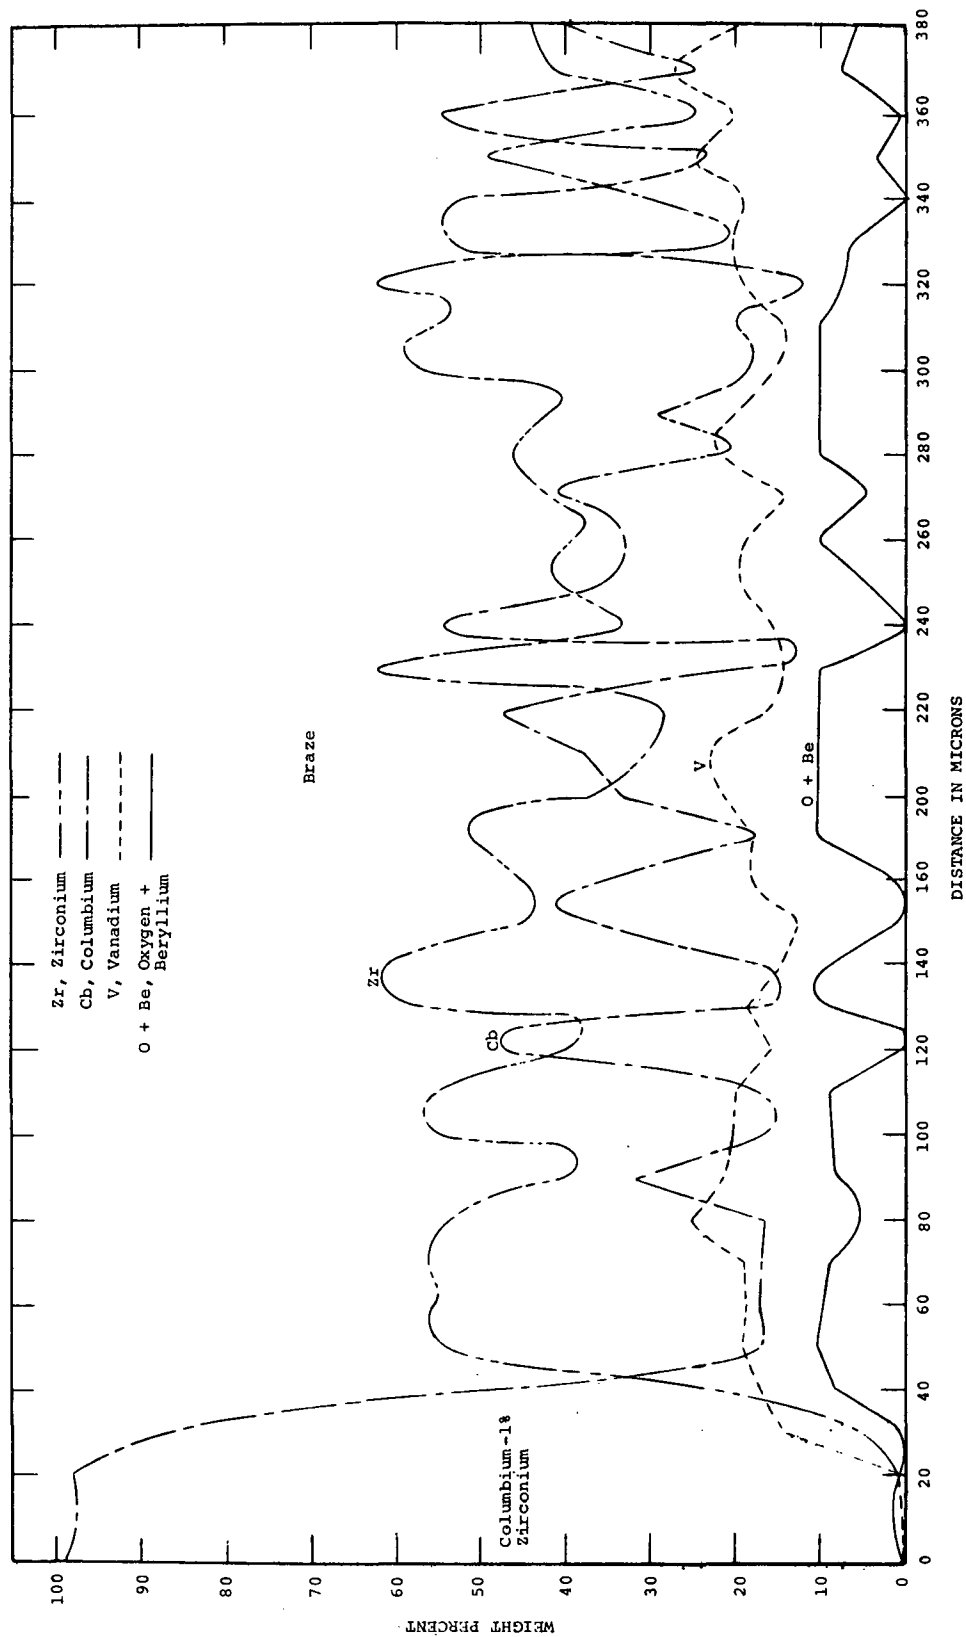
Examination of figures 23, 24, 25, and 26 reveals that the brazing alloy joints are not very homogeneous and that each joint structure is somewhat different. The bottom brazing alloy structures appear to be less homogeneous than the top brazing alloy structures. Most homogeneous of the probed joints is the potassium side of the top seal (figure 25). (It should be noted that this probe trace began in the columbium-1% zirconium end member, crossed a fillet of brazing alloy, and terminated at the edge of the fillet.) The probe trace for the other side of the top seal (figure 26) shows this brazing alloy to be less homogeneous. Columbium from the columbium-1% zirconium end member appears to have diffused into the brazing alloy during the brazing cycle. (This probe trace began in the beryllia, traversed the brazing alloy, and terminated in the columbium-1% zirconium.) Comparing figure 24 with figure 26 one can see that the figure 24 brazing alloy is much less homogeneous, has narrower zirconium-rich regions, and has substantially more columbium. The columbium content in figure 24 brazing changed from 65 percent to 15 percent in ten microns. It appears that the zirconium precipitated, leaving a matrix rich in columbium and vanadium. The figure 24 brazing alloy is approximately half the thickness of the figure 26 brazing alloy. Figure 23 shows a brazing alloy fillet on the other side of the figure 24 brazement. This fillet is less homogeneous than the fillet in figure 25 but more homogeneous than the brazing alloy in figure 24. The columbium content in the figure 23 brazing alloy is not as high as that in the figure 24 brazing alloy. In the top seal brazing alloys (figures 25 and 26), the vanadium and columbium seem to be related in that

Figure 23. - Electron Microprobe Analyses Across Potassium Exposed Side of Aged (10,000 Hours at 1300° F) Bore Seal Cap-sule (Columbium-1% Zirconium and 60Zr-25V-15Cb Braze Alloy) Bottom Seal.

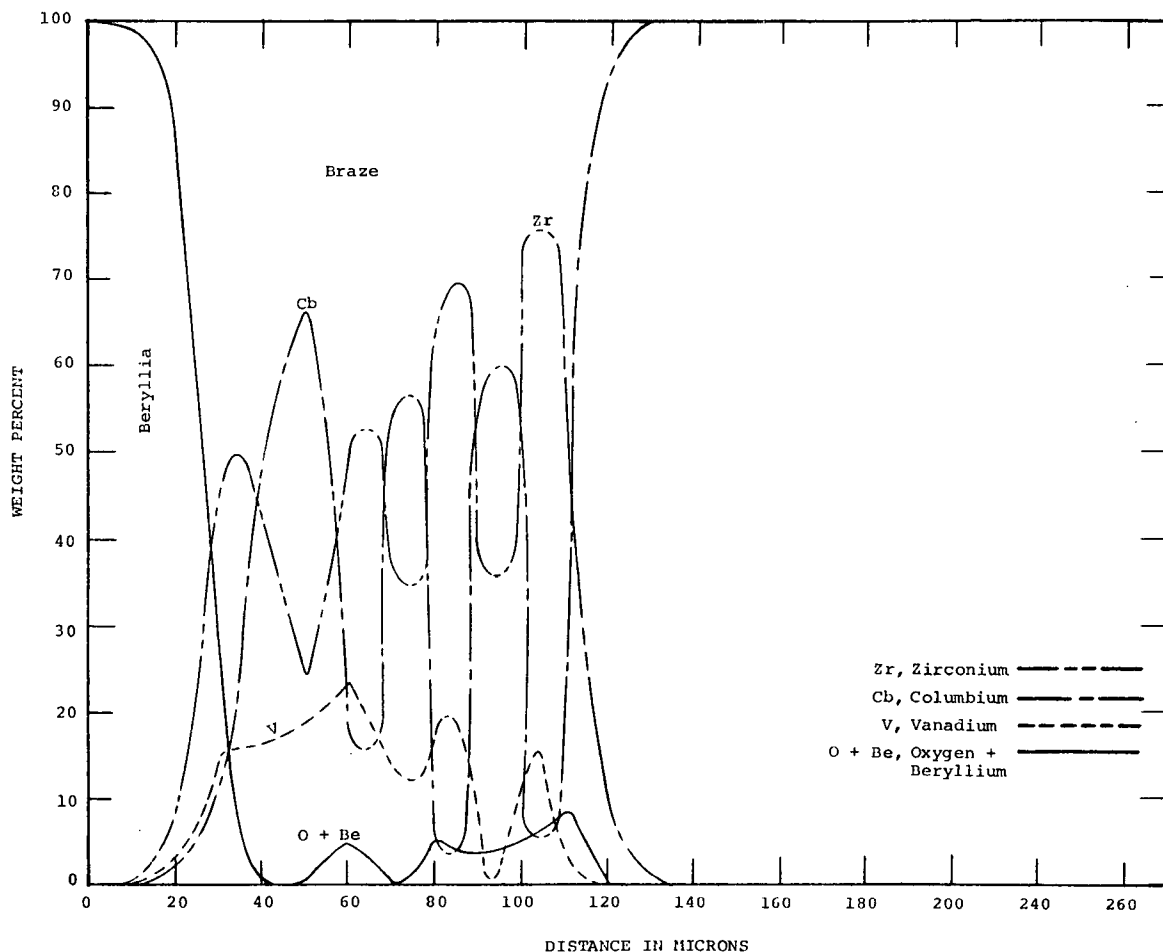
Figure 24. - Electron Microprobe Analyses Across Vacuum Exposed Side of Aged (10,000 Hours at 1300° F) Bore Seal Capsule (Beryllia, 60Zr-25V-12Cb Braze Alloy, and Columbium-1% Zirconium) Bottom Seal.

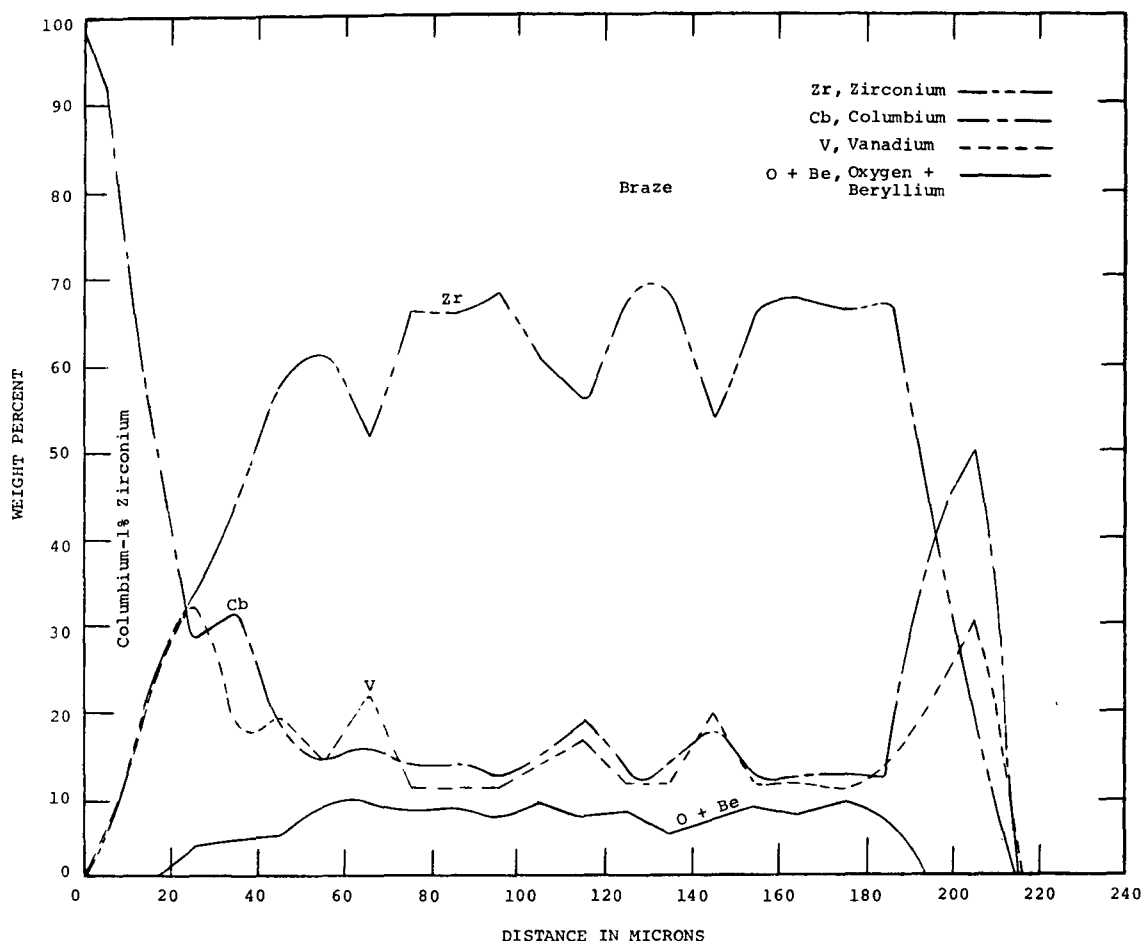
Figure 25. - Electron Microprobe Analyses Across Potassium Exposed Side of Aged (10,000 Hours at 1300° F) Bore Seal Capsule (Columbium-1% Zirconium and 60Zr-25V-15Cb Braze Alloy) Top Seal.

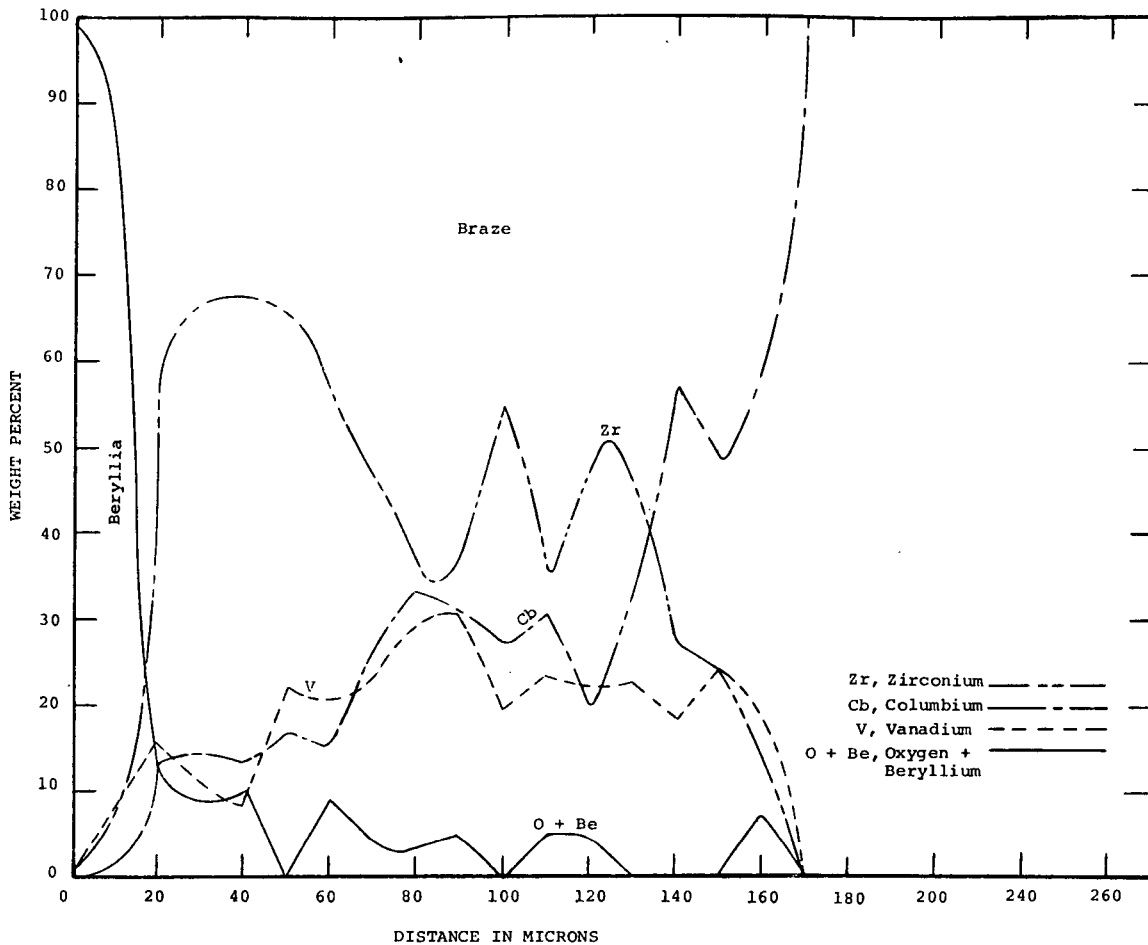
Figure 26. - Electron Microprobe Analyses Across the Vacuum Exposed Side of Aged (10,000 Hours at 1300° F) Bore Seal Capsule (Beryllia, 60Zr-25V-15Cb Braze Alloy and Columbium-1% Zirconium) Top Seal.

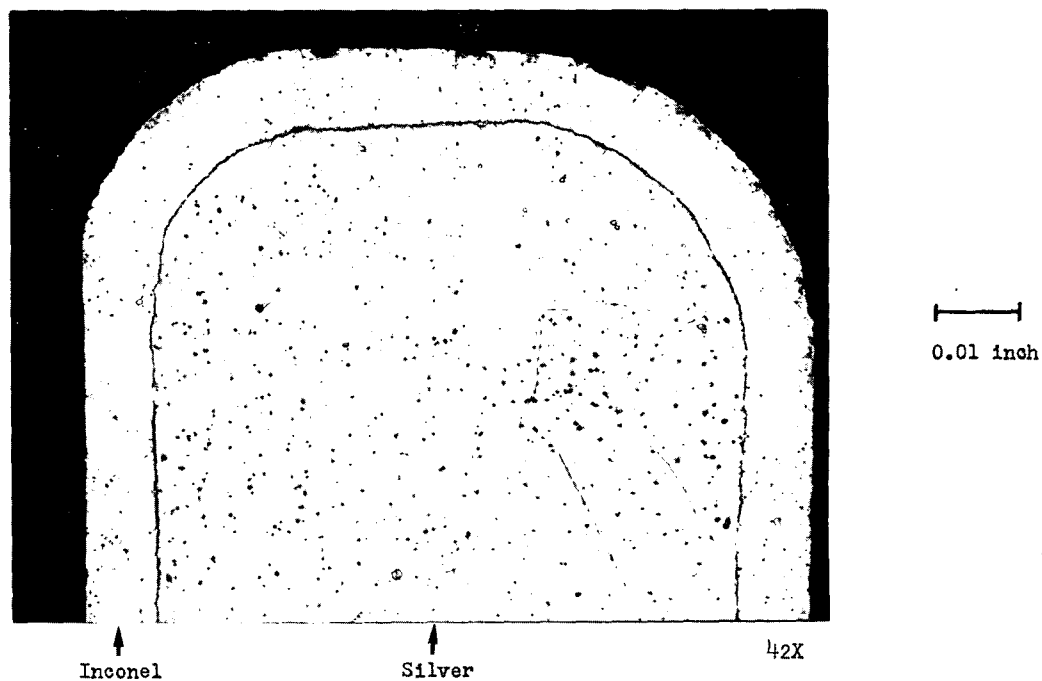
Metallographic Examinations of Inconel-Clad Silver Conductors. - Metallographic examinations were performed on unaged and aged Inconel-clad silver stator conductors from both end turn and slot. Figure 34 is representative of aged conductor from both end turn and slot. No differences were detected between the silver or the Inconel microstructures of the two aged specimens. Figure 35 is a photomicrograph of unaged conductor. A comparison of aged and unaged conductors showed considerably larger grains in the aged Inconel and somewhat larger grains in the aged silver. Grain growth found was considered normal for the aging conditions. There was no evidence of diffusion of silver or chromium in either aged conductor specimen.

Figure 35. - Photomicrograph of Conductor From Stator Slot After 10,000-Hour, 1300° F 10<sup>-9</sup> Torr Pressure Exposure. (42X)

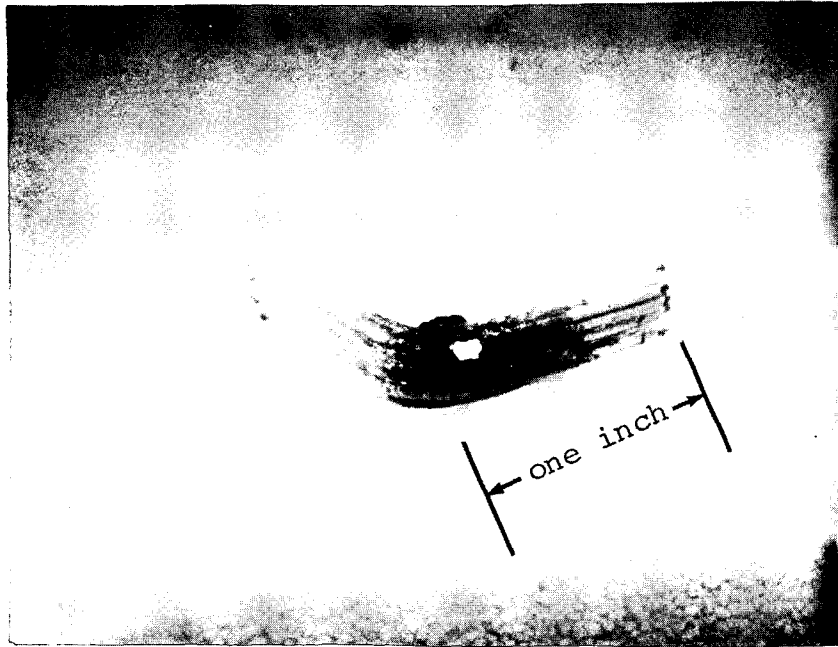
(b) Primary (high voltage) winding failed after 244 hours at test temperature (1300°F hot spot).

Figure 44. - View, After Disassembly, of the Failure Region in the 1300° F Transformer, Primary Winding, Fourth Layer from the Outside.

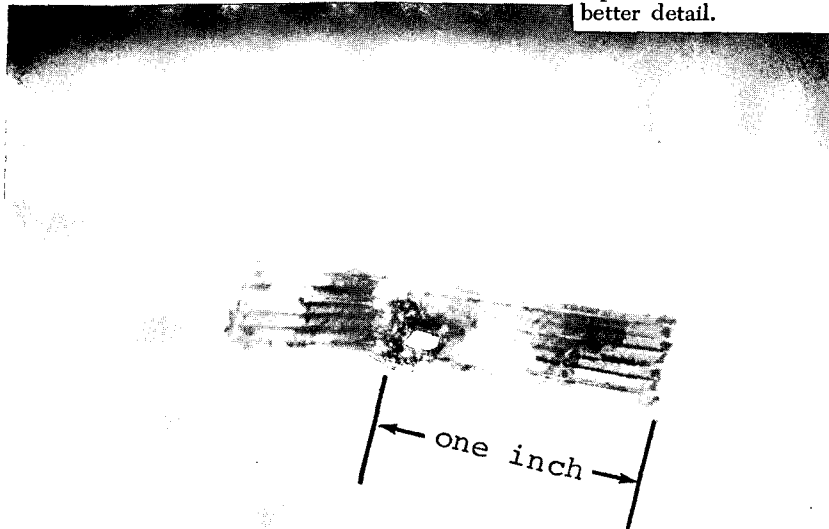
Figure 45. - View, After Disassembly, of the Failure Region in the 1300° F Transformer, Primary Winding, Fifth Layer from the Outside in the Foreground.
